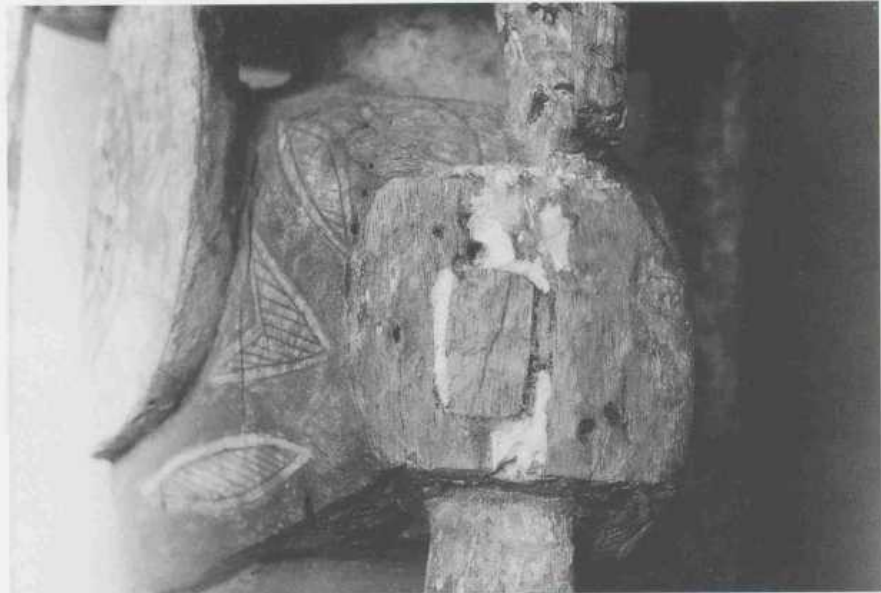
*Ill.19. Figure no.8, detail of left shoulder showing the damaged mortise and tenon joint with broken off tenon wedged in its housing. At least 6 nail holes and plaster infilling attest to subsequent attempts to fix the arm in place.*
